8 Chimneys Lagoon (#8)

8.1 Introduction

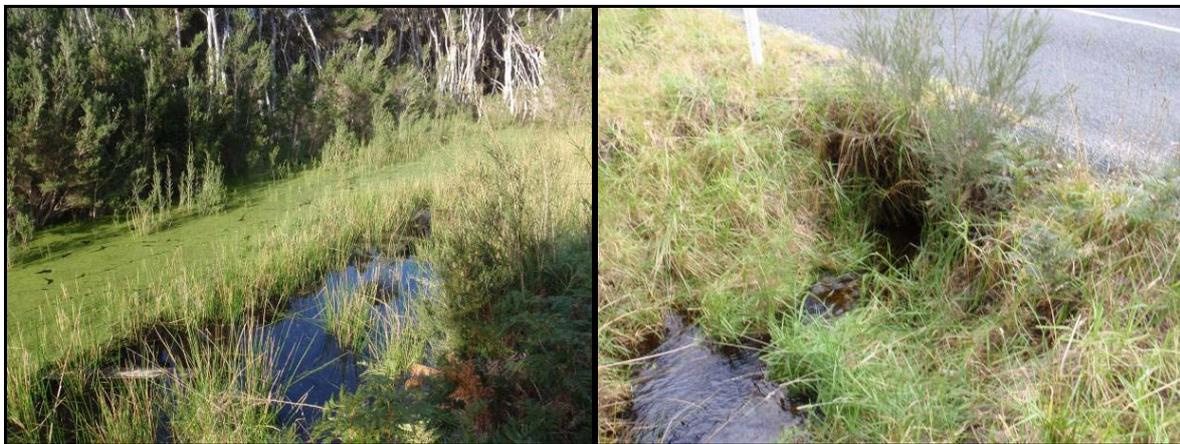
The mouth of Chimneys Lagoon has been modified by construction of St Helens Point Road and is now confined to small culverts. Based on aerial photos, the natural mouth of the lagoon appears to have occupied the adjacent beach area, and was probably intermittently connected to Georges Bay. It is plausible that the large vegetated swampy area between the road and the open water of the lagoon has been created since road construction due to through infilling. Restricted outflow from the lagoon now occurs via an under road culvert and overgrown channel. Water level in the lagoon is controlled by the level of the outlet, which probably leads to more stable water levels as compared to pre-road conditions.

Water entering the lagoon is likely to vary in water quality, from high quality natural runoff from the creeks to poor quality runoff from the surrounding residential development and adjacent roads. The proximity of the sewage treatment pond also poses a risk of leachate or spills entering the lagoon. The lack of flushing of the lagoon combined with possibly nutrient rich inflows leads to stagnation and promotes algal growth, as was apparent in August 2009 following an extended period of rain.

Photo 8.3. Left - Stagnant water near outlet of Chimney Lagoon showing algal growth

Photo 8.4. Right - Culvert at outflow of Chimney Lagoon.

1. Encourage planning laws which restrict further development within a defined buffer zone around Chimneys Lagoon.
2. Improved flushing of the lagoon would increase its resilience to catchment pressures. This could be accomplished to various degrees by clearing vegetation from the existing culverts to increasing the connection of the lagoon to Georges Bay through modification of the road.

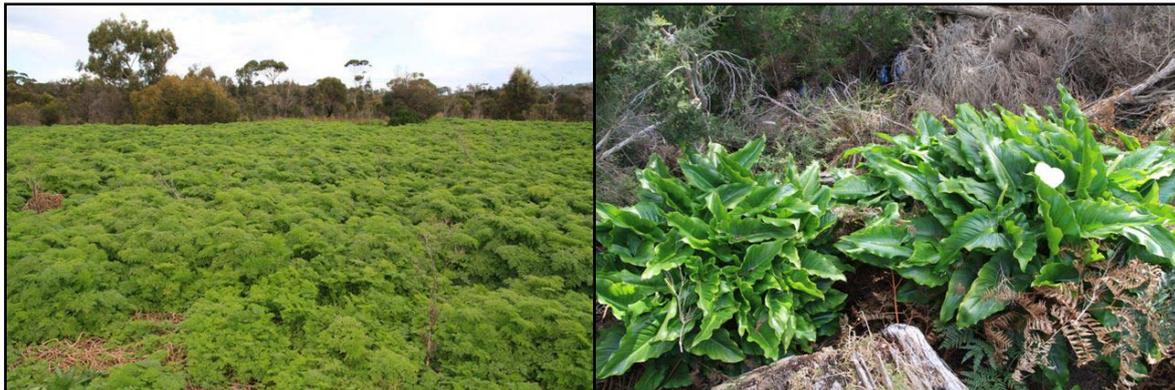
environmental weeds. The species are - arum lily (*Zantedeschia aethiopica*), blue psoralea (*Psoralea pinnata*), hemlock (*Conium maculatum*) and trailing african daisy (*Osteospermum fruticosum*). All four species recorded occurred in disturbed Extra-urban miscellaneous (FUM) areas or on the edges of the native vegetation areas, and are likely to have established from dumped garden waste in these areas. The current levels of infestation within the study area are low, and should be controlled now before these species are allowed to spread. Further larger infestations of hemlock and trailing african daisy occur immediately outside of the study area. See figure 8 for weed location and infestation details.

Photo 8.6. Left - Extensive hemlock (*Conium maculatum*) infestation just outside of the study area in degraded land.

Photo 8.7. Right - Arum lily (*Zantedeschia aethiopica*) infestation.

- **Weeds – Low Threat.** Arum lily, blue psoralea, hemlock and trailing african daisy occur in disturbed areas around the lagoon. The current levels of infestation within the study area are low, and should be controlled now before these species are allowed to spread. Further larger infestations of hemlock and trailing african daisy occur immediately outside of the study area, and will act as a source of recurring infestation.

4. Immediate weed control program, including several years of follow up work, targeting Arum lily, blue psoralea, hemlock and trailing african daisy.
5. Remove dumped rubbish from around and within the lagoon. Use trash racks over storm water drains to stop large particles of rubbish from entering the lagoon.
