8 Chimneys Lagoon (#8)

8.1 Introduction

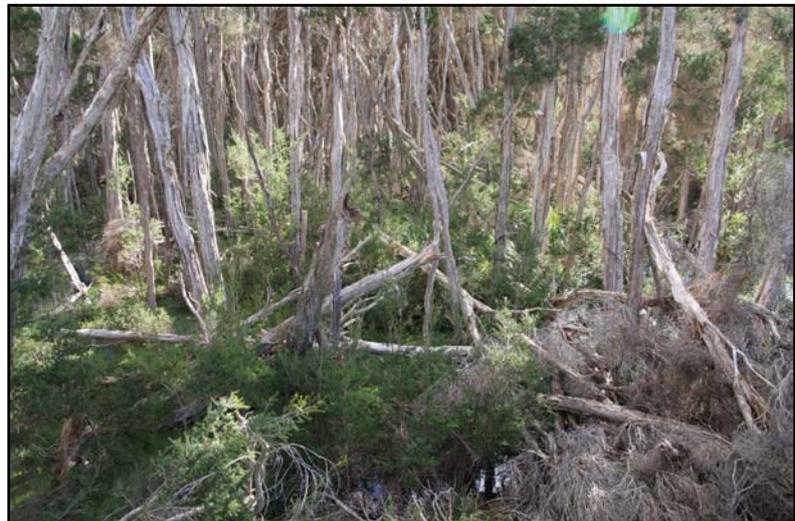
Photo 8.13. Chimneys Lagoon looking in to *Melaleuca ericifolia* swamp forest.

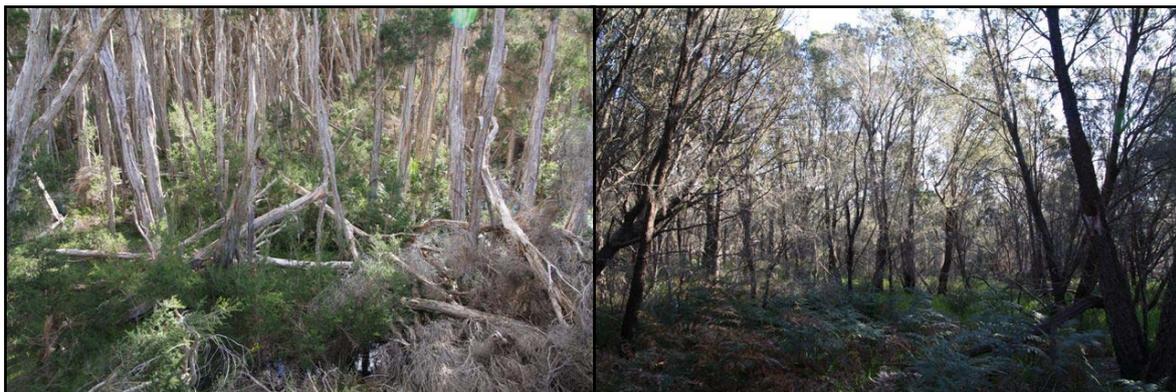
Photo 8.3. Left - *Melaleuca ericifolia* swamp forest (NME).

Photo 8.4. Right - *Allocasuarina littoralis* forest (NAL).

Of the native vegetation communities recorded two are considered to be threatened under the Tasmanian *Nature Conservation Act 2002*. They are *Melaleuca ericifolia* swamp forest (NME) and *Allocasuarina littoralis* forest (NAL). Together they cover 53% of the vegetated area (excluding open water/sea (OAQ)). Full details of vegetation communities recorded, their threatened status and their condition is provided below in Table 8.2, and their distribution is shown in Figure 8. Full species lists for each vegetation community are provided in Appendix 14.

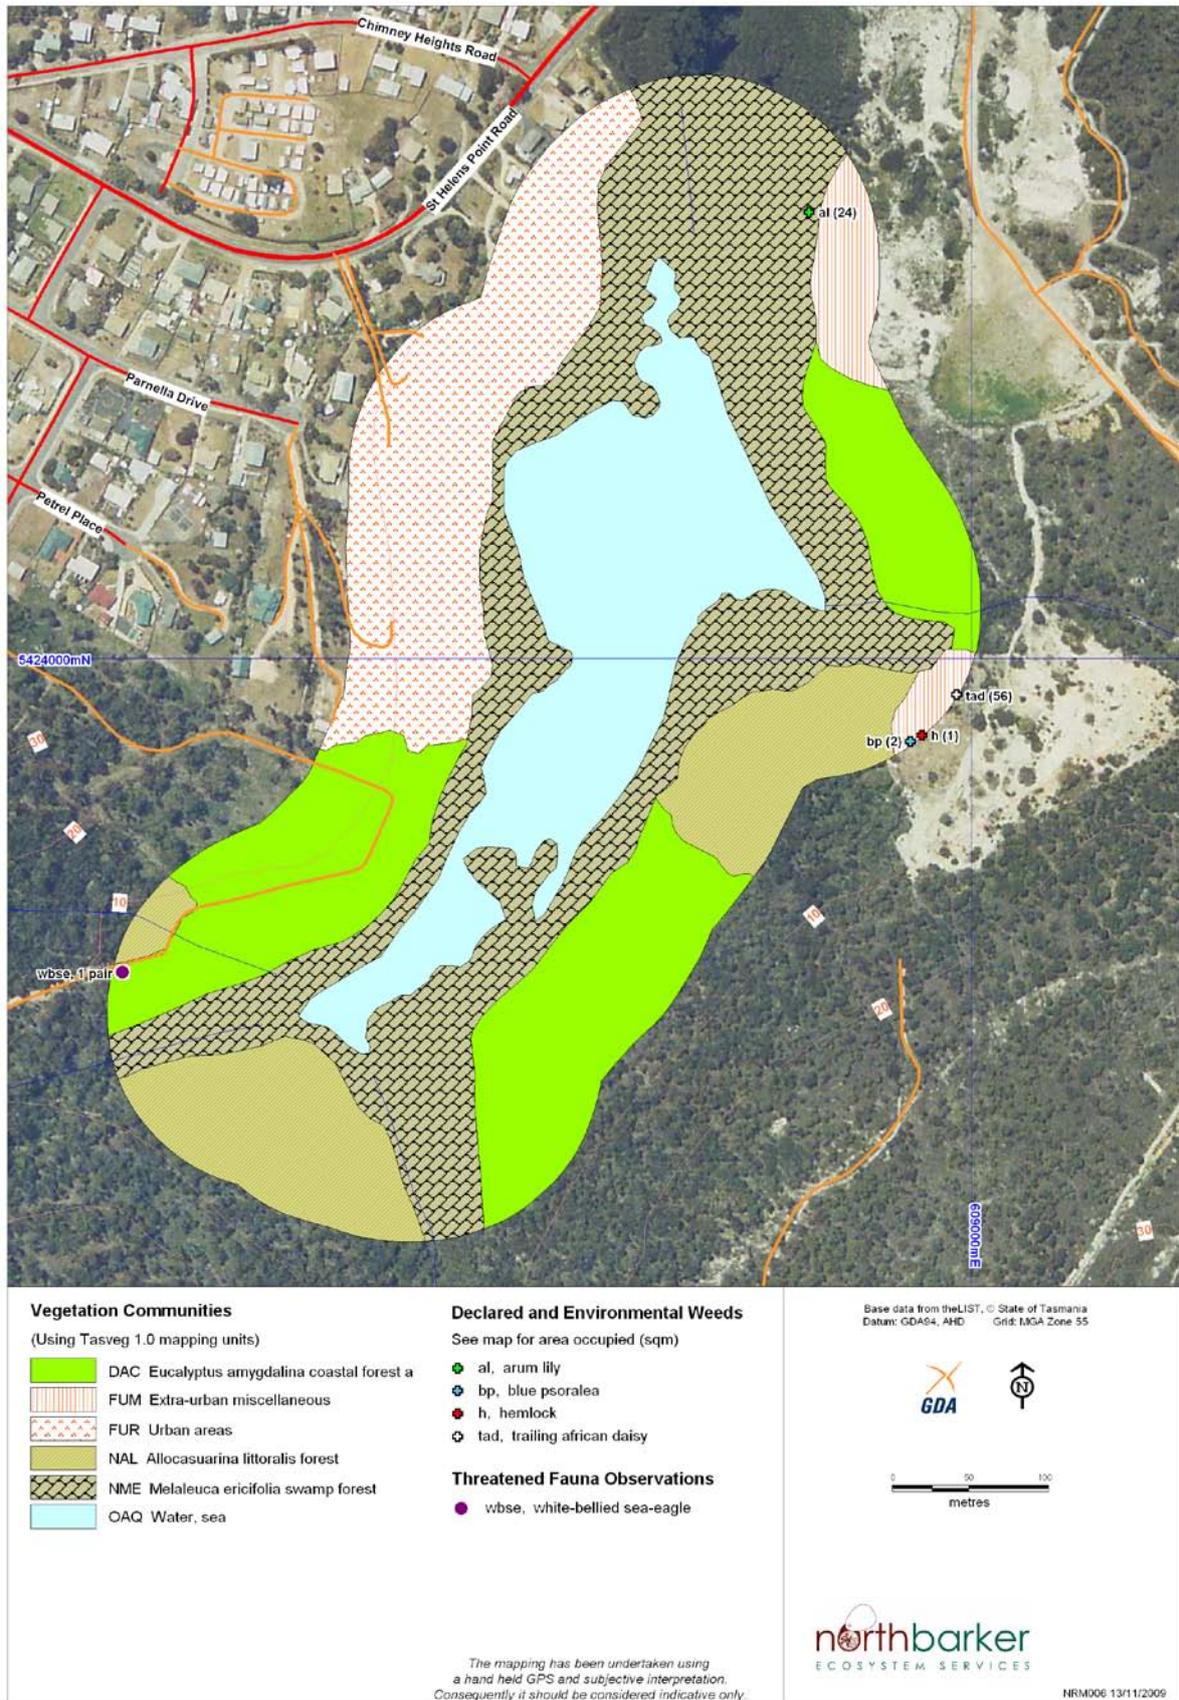
Figure 8 – Vegetation Communities, Weeds and Threatened Fauna for Chimneys Lagoon

environmental weeds. The species are - arum lily (*Zantedeschia aethiopica*), blue psoralea (*Psoralea pinnata*), hemlock (*Conium maculatum*) and trailing african daisy (*Osteospermum fruticosum*). All four species recorded occurred in disturbed Extra-urban miscellaneous (FUM) areas or on the edges of the native vegetation areas, and are likely to have established from dumped garden waste in these areas. The current levels of infestation within the study area are low, and should be controlled now before these species are allowed to spread. Further larger infestations of hemlock and trailing african daisy occur immediately outside of the study area. See figure 8 for weed location and infestation details.

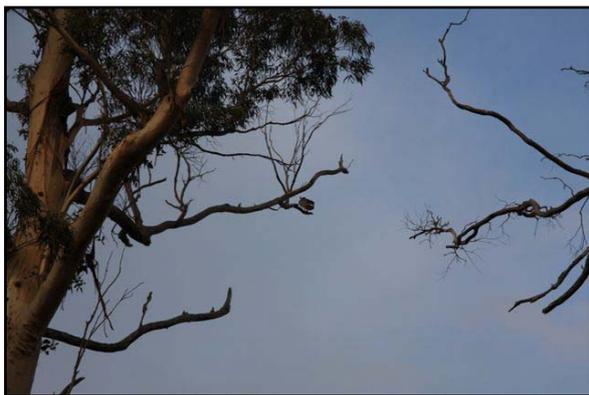
Photo 8.5. White-bellied Sea-Eagle (*Haliaeetus leucogaster*) in *Eucalyptus globulus* tree.
